REPORT OF INVESTIGATION

Surface Coal Mine

Fatal Machinery Accident
March 12, 2007

Double E Augering Inc.
No. 3
Feds Creek, Pike County, Kentucky
I.D. No. 15-18940

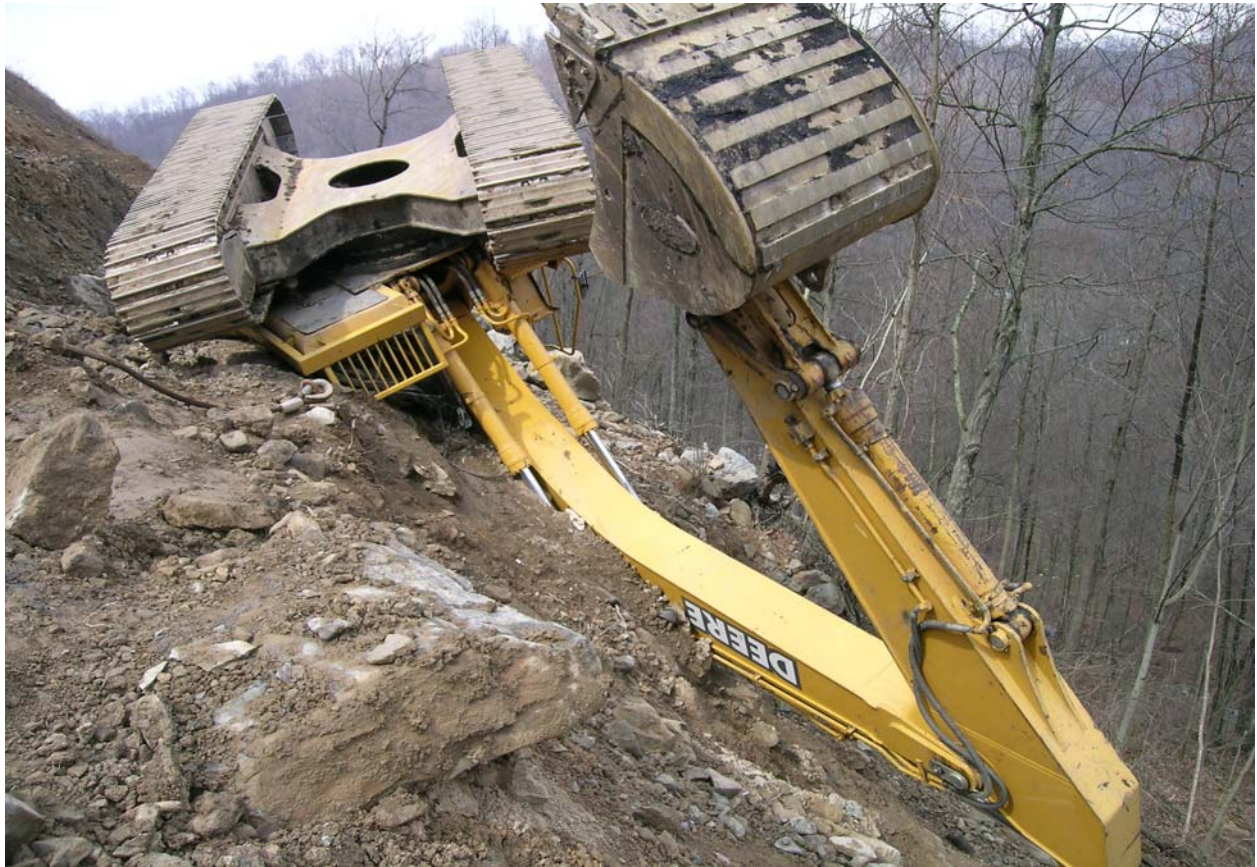
Photo of Accident Scene

At approximately 4:00 p.m. on March 12, 2007, Charles I. Griffith, a 47-year old foreman/excavator operator with 29 years mining experience, 16 months at this mine, received fatal injuries when the John Deere 330C LC track-mounted excavator which he had been operating overturned from an elevated mine bench. Griffith had been loading and moving shot rock overburden while positioned on the narrow bench, digging toward the excavator. The excavator was positioned with the left (operator's) side track on the edge of the upper bench, when Griffith began trying to reposition the machine away from the edge by using the boom. When down pressure was applied to the boom, the rear portion of the track went over the edge of the bench and the excavator began to roll over onto the lower bench. As the excavator continued rolling over, the cab was crushed and the victim was fatally injured.

The accident occurred because the width of the elevated mine bench was not sufficient to insure safe operation of the excavator.

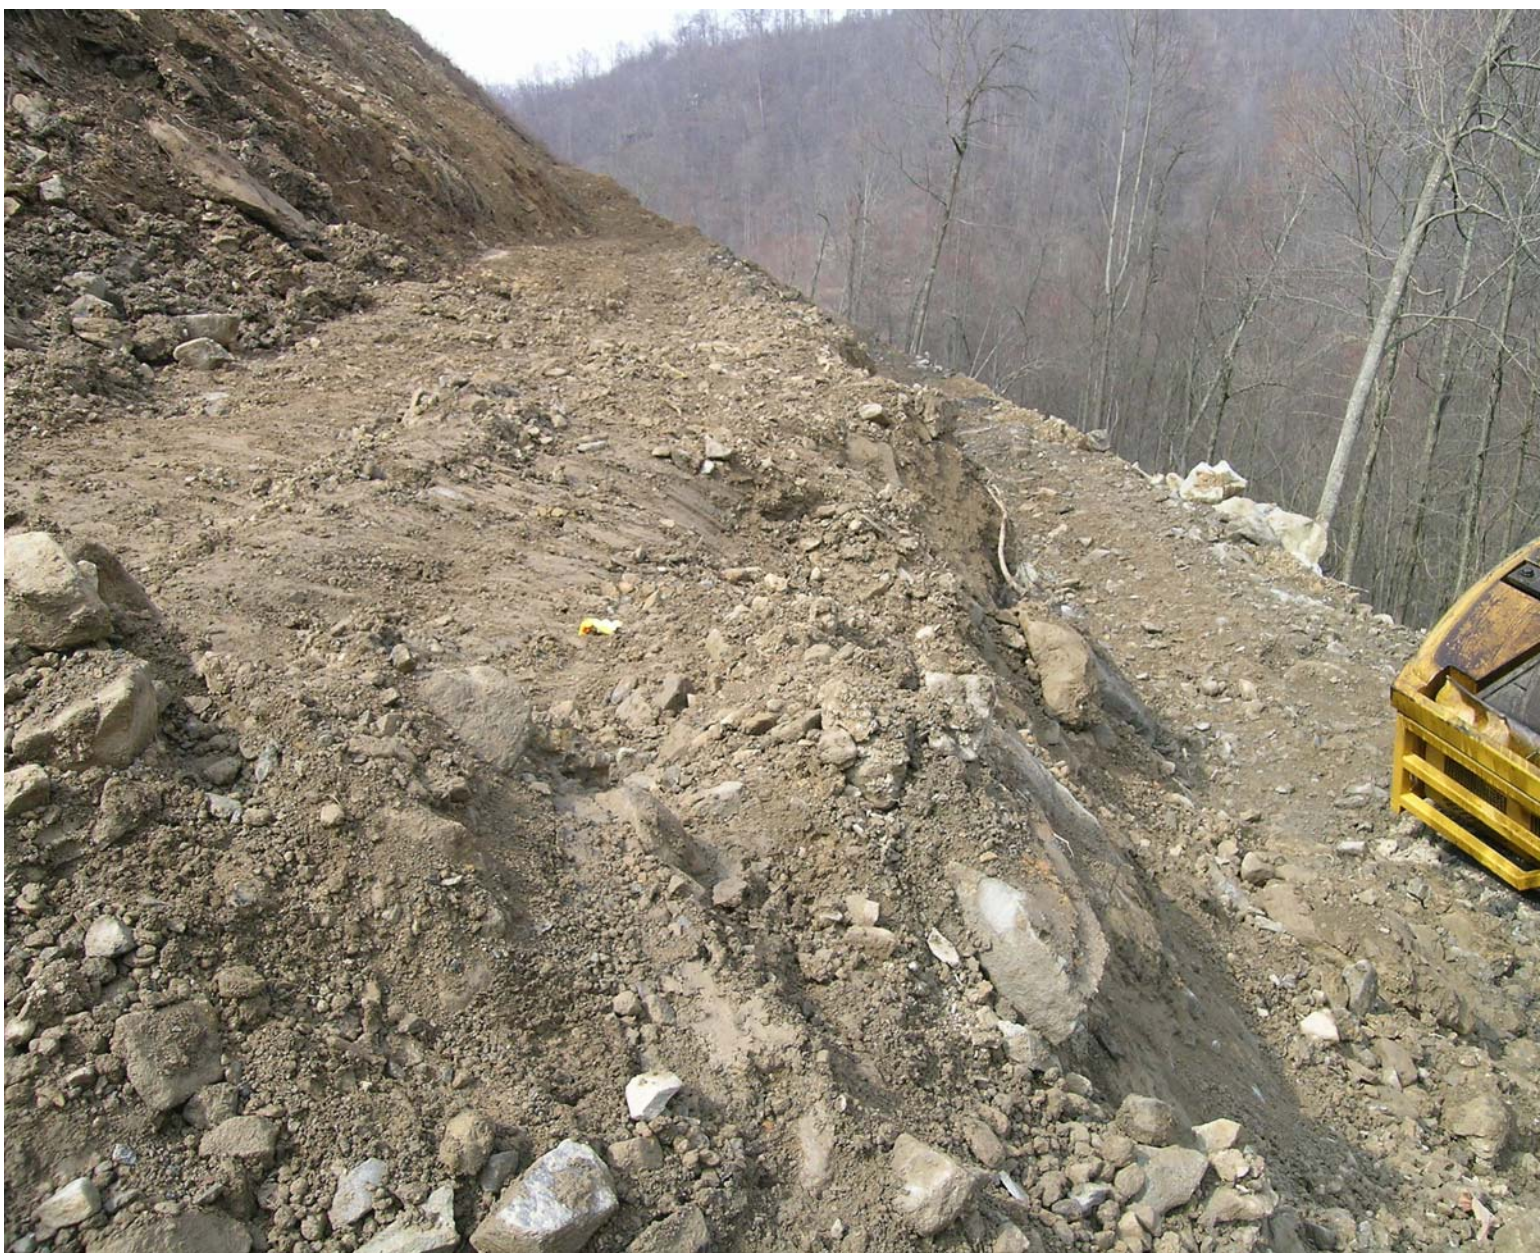
Photo showing upper and lower benches

Prior to the accident two mine benches had been developed along the outcrop in advance of the pit. The upper bench had been established in the previously blasted overburden (spoil) and used as access to the auger. The bench was 13 feet wide at the accident location. The lower bench had been dozed into the in-place shot rock to provide a diversion ditch during the previous shift in order to comply with the reclamation permit. The lower bench was approximately eight feet in elevation below the upper bench and was 12 feet wide.

The accident occurred because safe conditions for operating the excavator on an elevated mine bench were not provided. The width of the bench was not sufficient to insure safe operation of the excavator. The upper mine bench was measured to be 13 feet wide and the excavator tracks were 11 feet, 2 inches wide. The excavator was being operated on the edge of the bench in order to allow rotation of the deck.

Corrective actions: The mine operator developed a plan to prevent a similar occurrence of this accident. The ground control plan was revised to show when track-mounted equipment is being operated parallel to the outslope from an elevated bench on in-place shot material, the width of the bench will be a minimum of 1.5 times wider than the distance between the outside edges of the equipment tracks. The plan also requires training to be provided to the employees concerning the revised ground control plan and hazards associated with operating equipment from a mine bench.

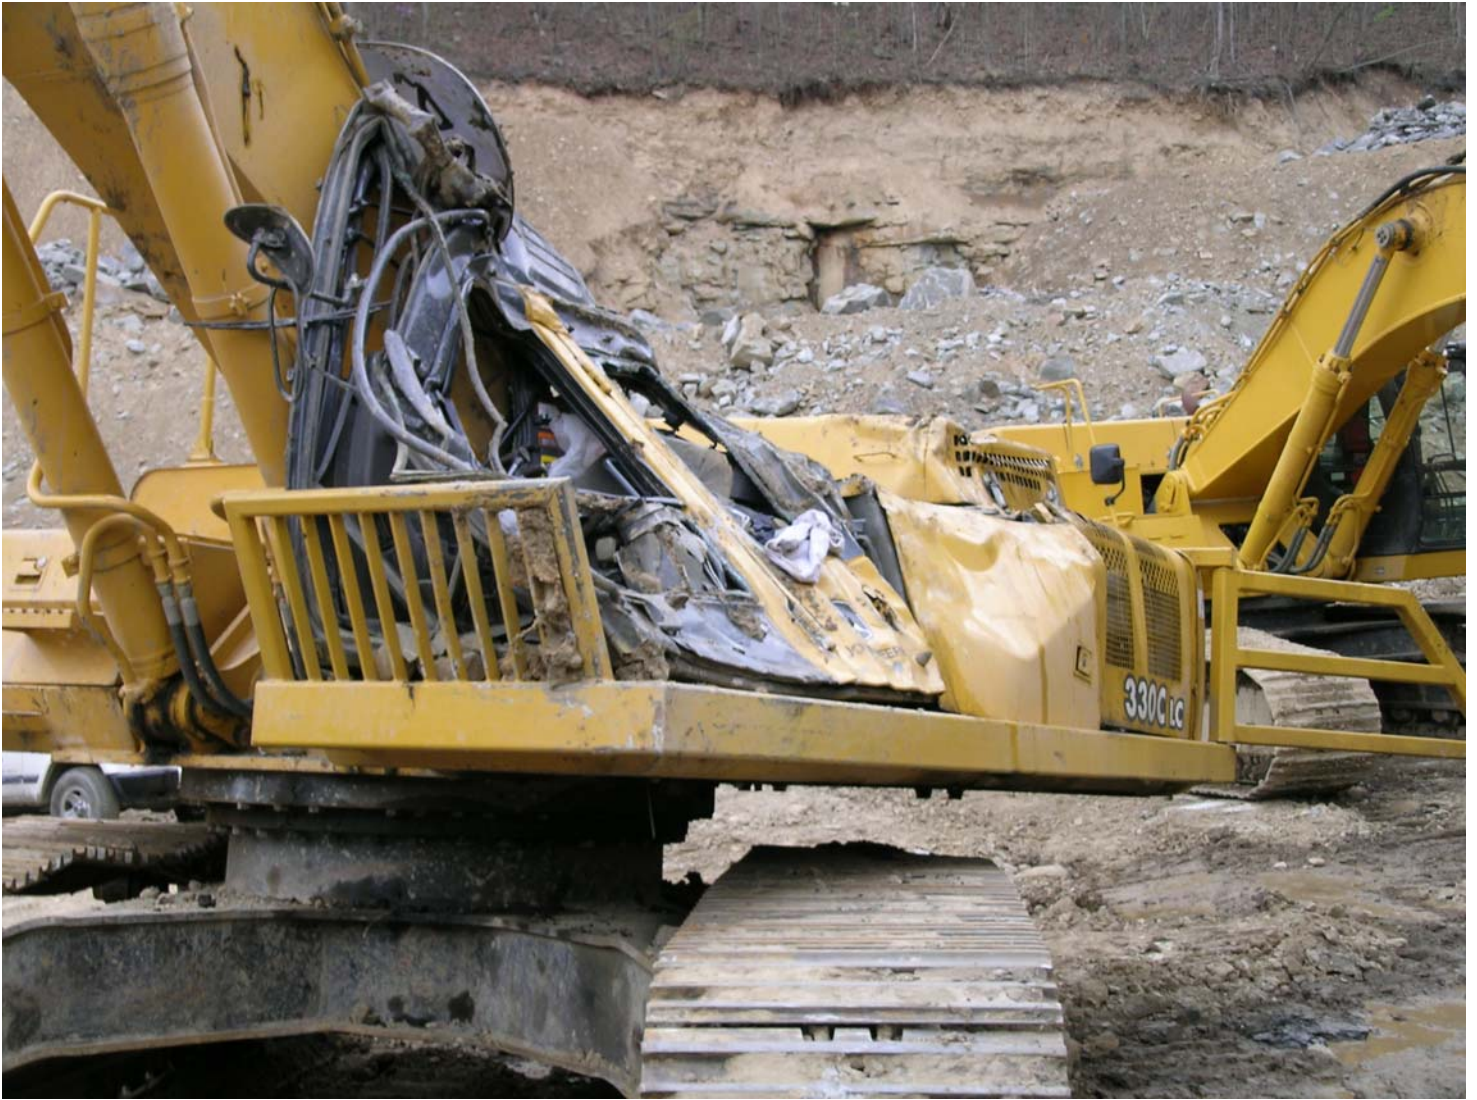
Photo showing extent of damage to cab of excavator

Altizer and Thornsberry ran to the overturned excavator to assist Griffith. Griffith was located in the cab, which had partially collapsed. They were unable to remove Griffith from the cab. Altizer ran to the auger to get assistance from the other miners while Thornsberry remained at the accident site with Griffith. Edmonds, Layne, and Dotson ran to the accident site while Altizer gathered medical supplies and tools before driving his pickup back to the site. Thornsberry stated that Griffith's pulse stopped within minutes after the accident and Edmonds, who is a MET, could detect no pulse upon arrival. Griffith was pronounced dead at 6:10 p.m. by Russell Roberts, Pike County Coroner.

The excavator was not equipped with a ROPS/FOPS (rollover protective structure/falling object protective structure) cab. Under current regulations at 30 CFR 77.403-1, ROPS is not required for this type of equipment. At the time of the accident the manufacturer did not provide ROPS as an option.
